The Mystery of the Ventilation Raises

Euler De Souza*

Queen's University, Canada

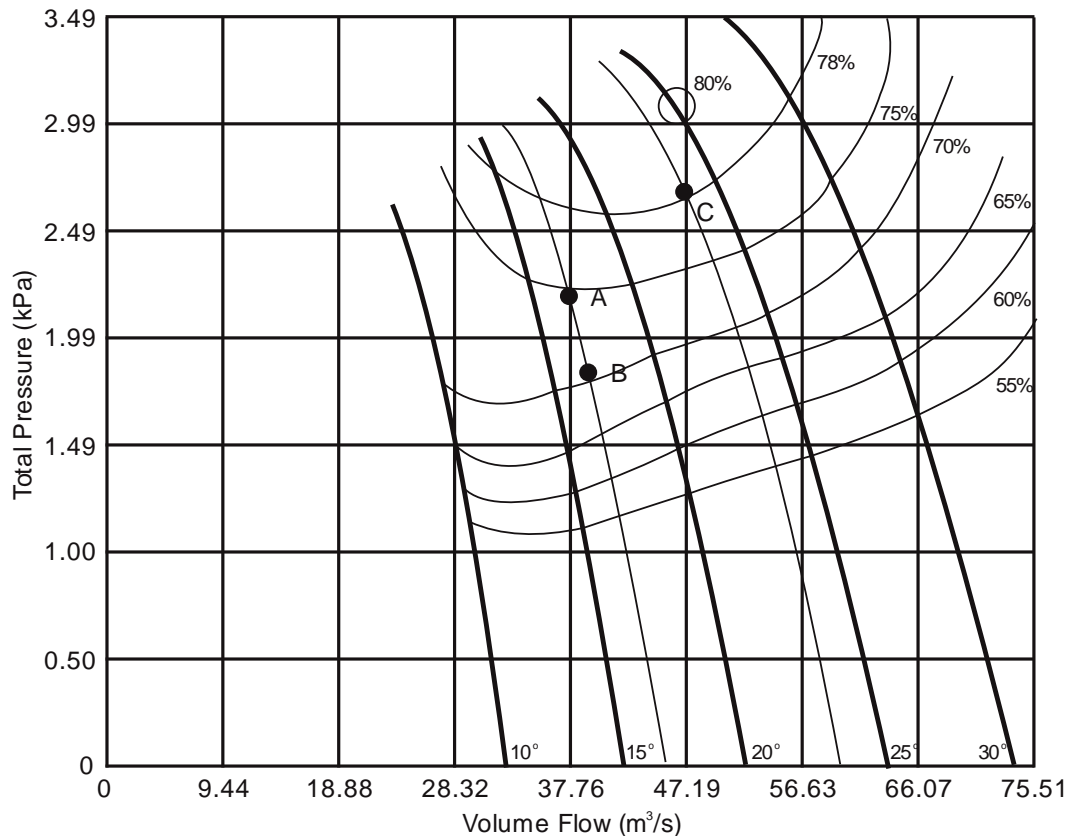
Figure 1: Exhaust Booster Fan Operating Points.

During operation, the primary exhaust fan would become unstable resulting in fan stall, structural fatigue damage and ultimately the destruction of its blades. This fan failure occurrence repeated approximately every 6 months.

Based on pressure and flow surveys, the raise static resistance was estimated at $0.94 \text{ N}\cdot\text{s}^2/\text{m}^8$, including shock losses.

A ventilation survey was conducted at the fan, and the fan flow was measured at $37.76 \text{ m}^3/\text{s}$. The fan total pressure, including assemblage shock losses, was determined at 2.06 kPa. The exhaust fan operating point, A, is shown in Figure 1. The fan efficiency is 75% and the brake power 104 kW. According to Figure 1, the fan operating point seems to be adequate.

When saturated air is exhausted in an upcast raise, as the saturated air rises in the raise, the barometric pressure decreases and consequently the temperature of the air decreases. This results in water being condensed out of the air. The water condenses as very small droplets which give the air a foggy appearance. As the air rises more water condenses onto these small droplets and they gradually grow to larger drops. Under such circumstances, the fan pressure will increase over a period of time while the airflow rate decreases over the same period. This phenomenon is named water blanketing. If the air travels up the raise at much less than 8 m/s, the drops will fall down, if the air is travelling much faster than 8 m/s, they will be carried up the raise. If the air velocity is such that drops of certain sizes are suspended in the air or move up or down the raise, the obstruction they create to airflow is sometimes increased to such an extent that a very considerable increase in raise resistance results. The increase in resistance pressure may adversely affect the fans serving the raise [1, 2].

The most dangerous air velocity, called critical velocity, is about 8 m/s. From the conducted survey, the air velocity in the raise was estimated at 8.29 m/s. It seems that it was taking approximately 6 months for water blanketing associated resistance to increase to the point of fan stall.

The operating point is now much lower on the fan curve, however the air velocity in the raise (8.6 m/s) is still within the critical air velocity range.

The first step was to install a cone in the fan. A 1.83 m outlet diameter, 1.24 m long cone was installed. The fan velocity pressure, including loss, was reduced to 0.37 kPa from 0.70 kPa (no cone). The fan total pressure, including assemblage shock losses, was determined at 1.84 Pa and the fan flow was estimated at $39.17 \text{ m}^3/\text{s}$. The resulting fan operating point, B, is shown in Figure 1. The fan efficiency is 70% and the brake power 103 kW.

The next step of the investigation was to change the fan blade setting in order to increase the fan flow and the raise air velocity. The fan blade angle was changed to 23 degrees, to operate at a flow of $47.2 \text{ m}^3/\text{s}$ and raise air velocity of 10.4 m/s.

With the new blade setting, the fan total pressure increased to 2.68 kPa and the brake power to 162 kW, with the fan operating at 78% efficiency. The resulting fan operating point, C, is shown in Figure 1.

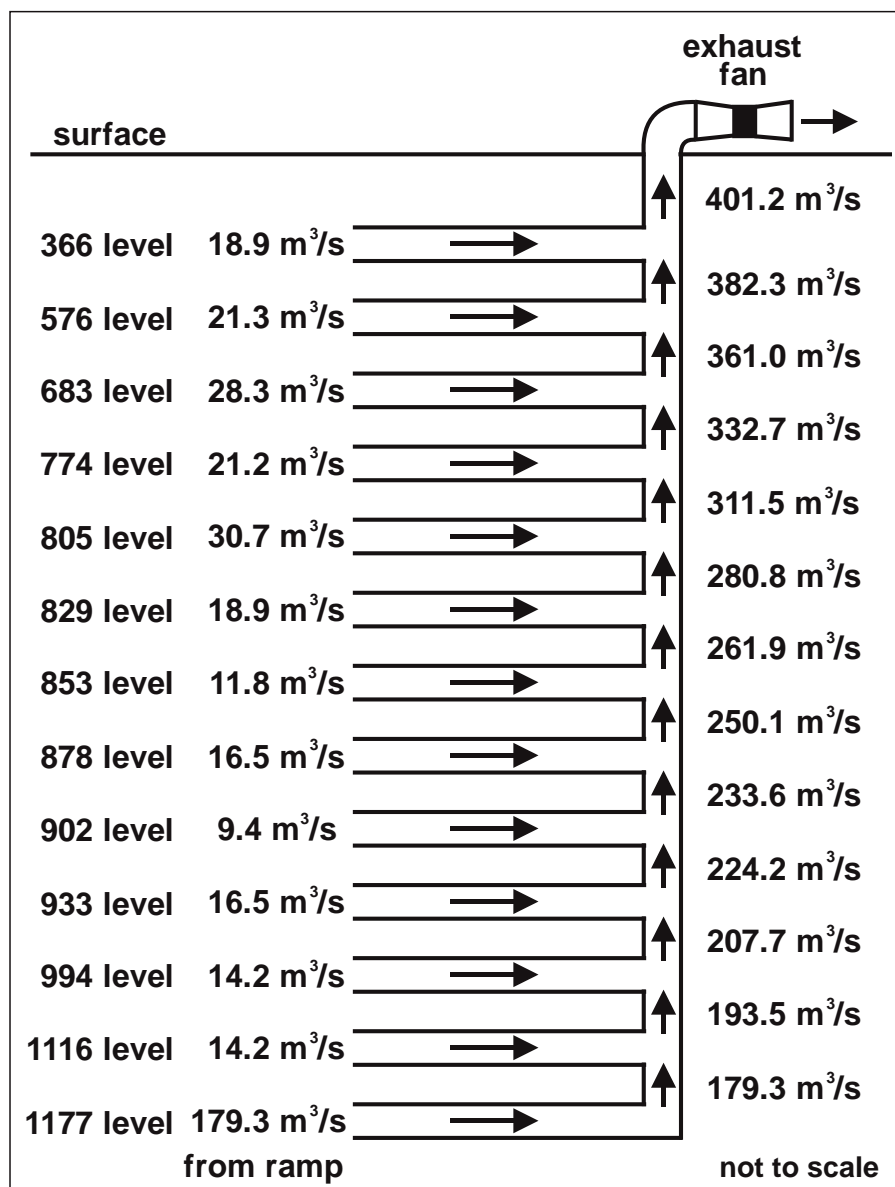
Figure 2: Simplified schematic of exhaust raise.

In an underground hard rock mine, a main exhaust raise serves the upper production section of the mine. The raise receives spent air from various levels and from an internal ramp servicing the lower levels (Figure 2).

Workers were investigating the fan, when instead they should have been checking the raise. A major production blast had been conducted in a stope in close proximity to the raise. Upon close inspection of the raise, a major ground fall was found in one of the raise transfers, as a result of the blast, restricting the airway and creating the noted increase in raise resistance. Cleanup and rehabilitation of the affected raise transfer were promptly completed and the fan operation restored to its normal.

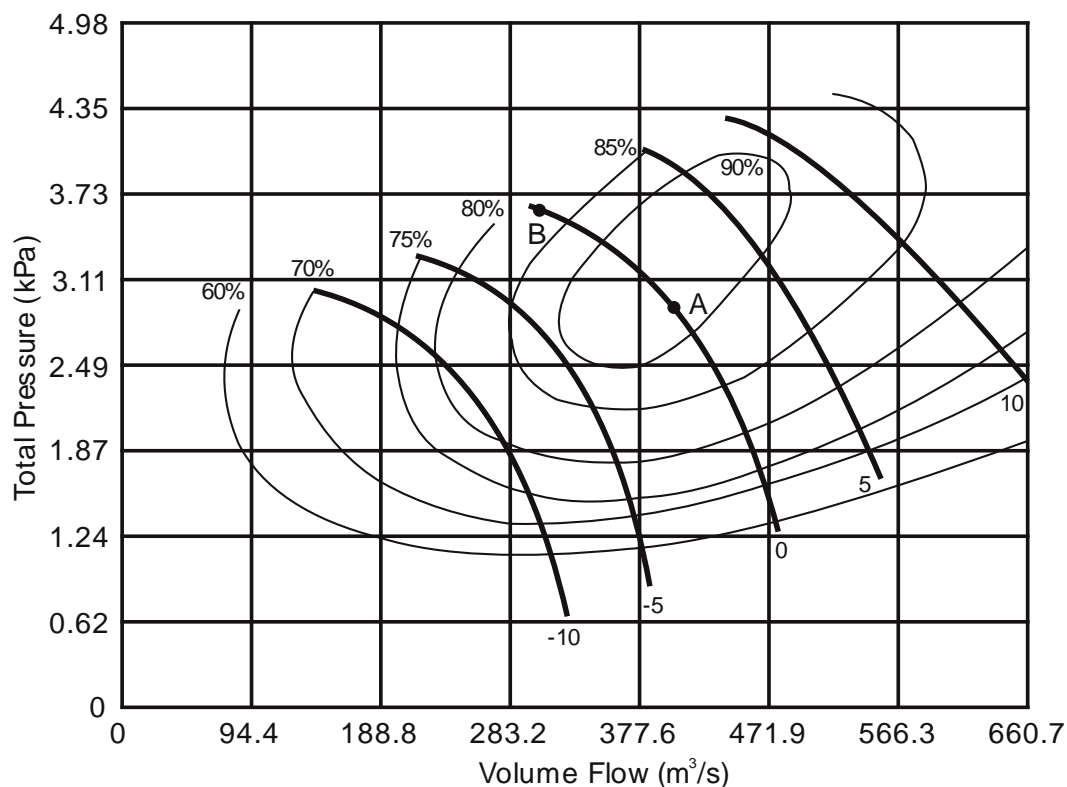
Figure 3: Exhaust surface fan curve.

The raise resistance was determined and the expected fan operating point, under normal conditions, was estimated at 401.2 m³/s and 2.9 kPa total pressure. The fan efficiency was determined 90% and the brake power at 1,292 kW. The exhaust fan operating point, A, is shown in Figure 3. This estimate matched very well with historical fan surveys conducted at the mine.

A ventilation survey was conducted at the fan, and the fan flow was measured at 305.4 m³/s. The fan total pressure, including assemblage shock losses, was determined at 3.62 kPa. The brake power was estimated at 1316 kW. The exhaust fan new operating point, B, is shown in Figure 3.

It was clear that the raise resistance had increased to a point where the fan was operating at a condition close to stall (Figure 3).

The combined major drop in flow and increase in pressure resulted in no substantial increase in power draw, as noted by mine personnel.
