MAINTENANCE, ENGINEERING AND RELIABILITY

VENTILATION MISTAKES AND CONSEQUENCES - REAL LIFE EXPERIENCES

*Euler De Souza
Queen's University
Kingston, Ontario, Canada
(*corresponding author: euler.desouza@queensu.ca)

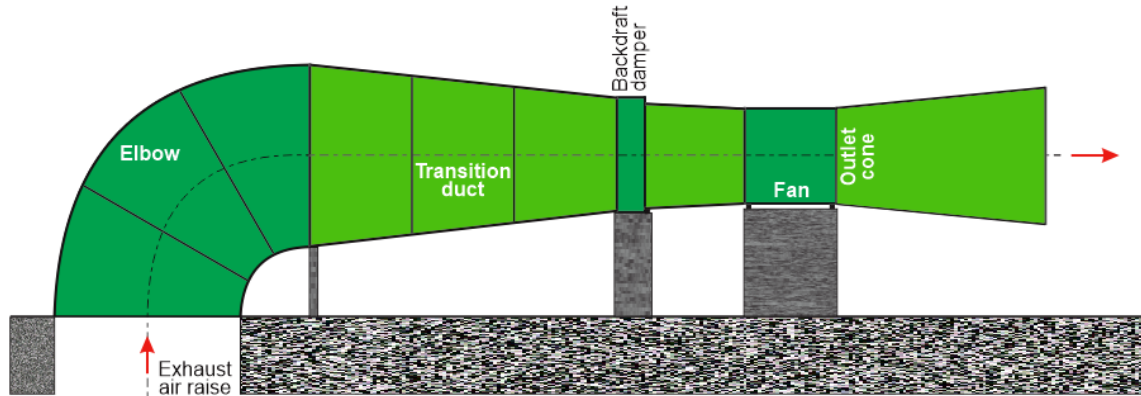
A return air raise, serviced by two surface fans, was designed to exhaust $190 \text{ m}^3/\text{s}$. The 2.13 m diameter fans were installed in two parallel stacks and designed to operate at a flow of $95 \text{ m}^3/\text{s}$ and 2.5 kPa total pressure. The fan assemblage design (Figure 1) called for the fans to be installed horizontally following a 90 degree elbow, $3 \text{ m} \times 2.5 \text{ m}$ in section. The elbow was to be connected to the 2.13 m diameter fans via two converging transition sections with a wall angle of approximately 6 degrees. The design fan outlet cone was 3.17 m in diameter and 4.6 m in length.

During normal operation of the system, in several occasions, fan blade failures would unexpectedly occur. Vibrational energy (pinging sound noticed by operators) seemed to have initiated the mechanical failure of the fans, this being normally associated with the formation of a fan stall condition.

Figure 1. Case Study 1: Original fan assemblage design

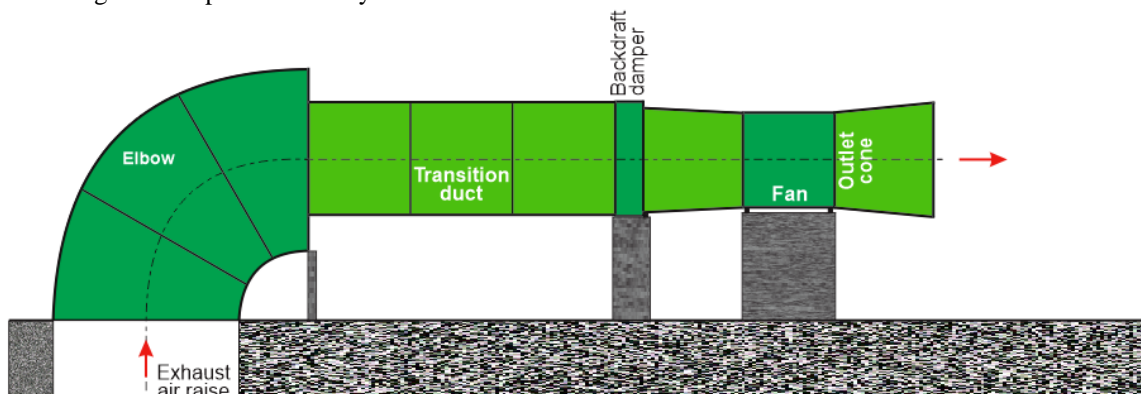
A detailed inspection indicated that the manufacturer did not follow the original assemblage design. The fans were connected to the elbow via two 2.13 m diameter, 6 m long, straight ducts (Figure 2). The connection to the elbow formed sudden contractions to the two stacks instead of the original gradual contraction design. This increased the shock loss resistance pressure by 37%. In addition, a much smaller cone (2.35 m diameter, 1.5 m long) was installed, increasing the cone losses by 82%. The two installation 'short-cuts' resulted in a fan total pressure of 2.8 kPa instead for the designed 2.5 kPa. This increase in resistance pressure brought the fan operation outside its normal operating range, causing a stall condition to occur. Also, the fans were drawing high amperages, with an input power of 396 kW, much higher than the original motor design size of 336 kW. All the fan operating parameters described above were verified following detailed pressure surveys.

Figure 2. Case Study 1: As-built fan assemblage

Changes to the fan assemblage were proposed to conform to his original design. The fan cones were to be replaced by the larger designed cones and the straight ducts were to be replaced by originally designed converging transition sections. Following the changeover, the fans performed according to the original expectations, with no further operational issues.

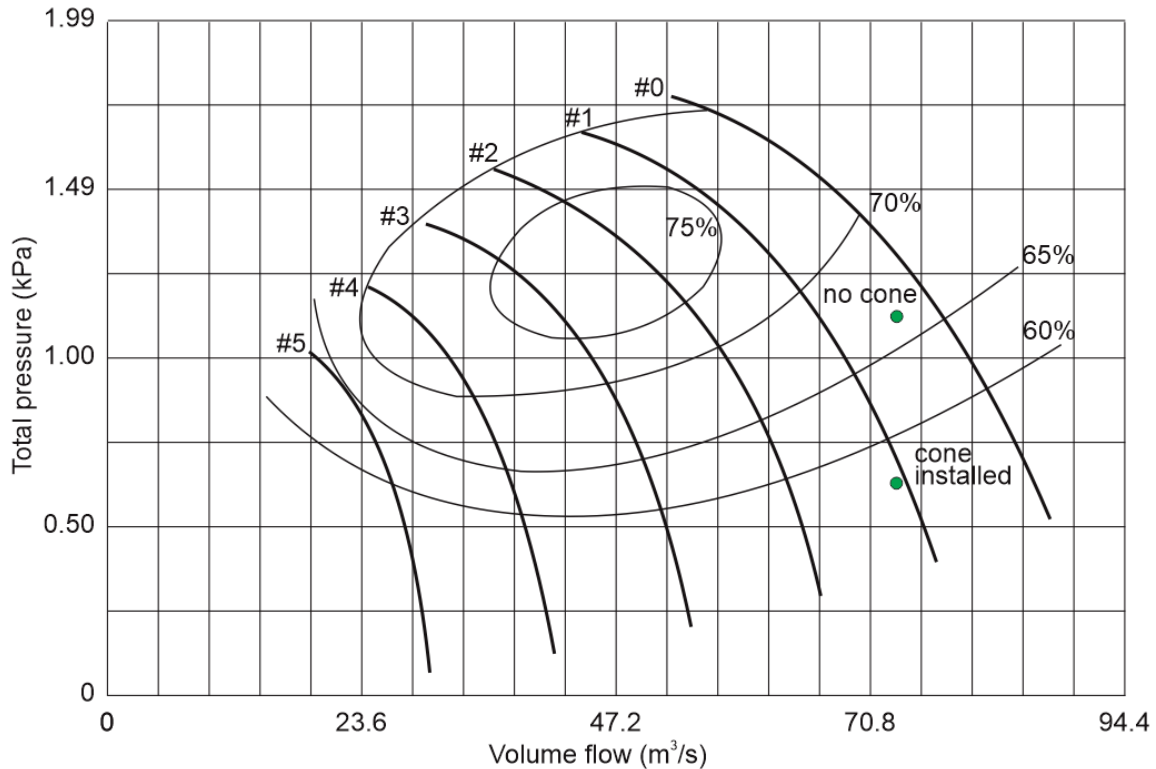
While conducting a ventilation energy audit for a hard rock mine, it was observed that an underground booster fan installed in a bulkhead, while operating adequately and supplying the required flow of 73 m³/s, was drawing considerable amperage and consuming excess energy. The fan diameter was 1.68 m and the hub diameter was 0.66 m. The fan had a 112 kW motor running at 1,200 rpm. The assessment found that while the booster fan was properly fitted with an inlet bell and screen, it did not have an outlet cone installed in it.

The fan operating points before and after the cone installation are shown in Figure 3. Fan operating cost savings approximating 41% were incurred, and a payback period of 8 months was determined. Following the confirmed savings, cones were installed in all other booster fan installations in the mine. This case demonstrates how a simple corrective action of a common poor practice can reduce power consumption and lower operating costs.

Figure 3. Case Study 3: Fan operating points

It was proposed to install a 2.18 m outlet diameter, 3.34 m long cone in the fan to save on operating costs while maintaining the same flow. Pressure and flow surveys were conducted after the cone installation and change in blade setting. The fan velocity pressure, including loss, was reduced to 0.37 kPa from 0.93 kPa (no cone). The fan total pressure, including assemblage shock losses, was reduced to 0.52 kPa from 1.12 Pa and the brake power flow was reduced to 82 kW from 139 kW for the same supply flow.

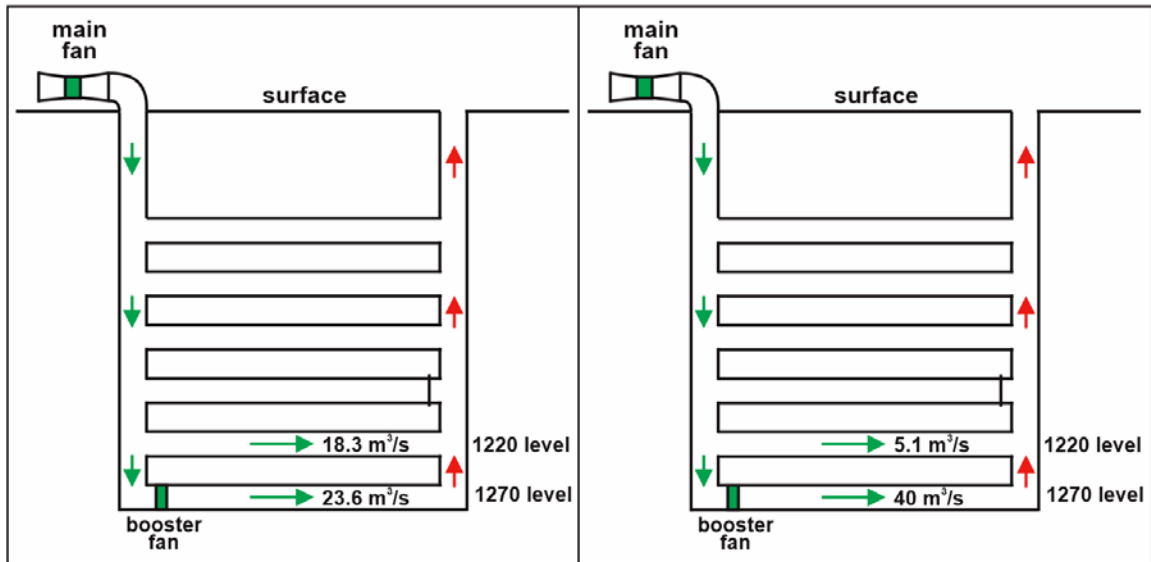
The investigation revealed that at the time of the blast, the level was being ventilated by only 5.1 m³/s and not by the expected flow of 18.3 m³/s, thus compromising ventilation quality and safety. A detailed assessment found that workers in a lower level (1270 m level) had changed the variable frequency drive (VFD) setting of a booster fan operating in that level. The fan had been installed to improve ventilation in the 1270 m level, which offered a higher resistance. Initially, the 1270 m level was being ventilated with 23.6 m³/s with the booster fan set at a lower rpm (Figure 4a). The change to the booster fan VFD setting increased the airflow to 40 m³/s (Figure 4b). The booster fan pressure increased from 0.13 kPa to 1.03 kPa. This resulted in a loss of pressure and reduction in airflow (to 5.1 m³/s) in the 1220 m level.

Figure 4. Case Study 4: Mine ventilation schematic showing a) design flow distribution and b) altered flow distribution

Had the workers increased the booster fan flow to $46 \text{ m}^3/\text{s}$, a full cessation of flow would have occurred in the 1220 m level, further compounding the issue. In this case, the booster fan would have been operating at the critical pressure (1.3 kPa), above which air recirculation between the two levels would have occurred.

The fan VFD was returned to its original setting, and the flows in the two levels were restored. The working crew received training and communication not to change the settings of any ventilation appliance, including doors, regulators, and fans installed in the mine.

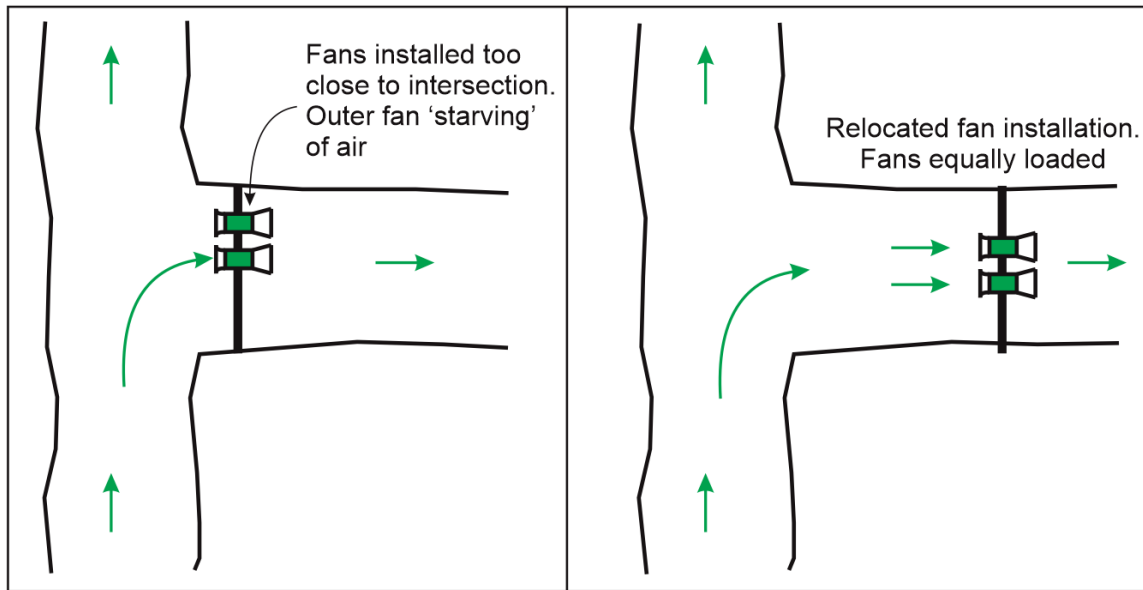
A bulkheaded booster fan system consisting of two fans in parallel was designed to transfer air from a main airway to a production area via an access drift driven perpendicular to the main airway. The booster fan system was installed in very close proximity to the intersection between the drifts (Figure 5a). This created a 'starving' condition on the outer booster fan. The improper siting of the booster fans created a lower flow volume feed and an uneven airflow volume loading of the blades on the outer fan. This could have led to fatigue failure associated with stress loading and unloading cycles of the fan blades. To correct the situation, the booster fans were relocated farther down the drift where air streamlines formed a full flow condition across the airway section such that both fans were equally loaded (Figure 5b). The aerodynamic conditions at the inlet and outlet of the fans were now balanced, and all blades were evenly loaded across the fan inlet area.

Figure 5. Case Study 5: a) Initial and b) relocated booster fan system siting

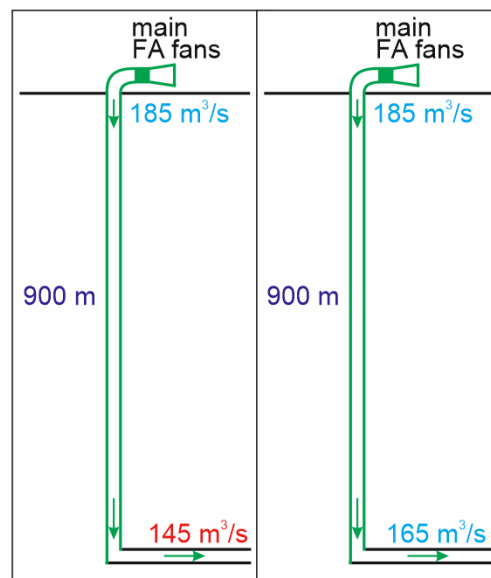
A new fresh air raise 4.3 m in diameter and 900 m long was driven and 1.943 m diameter surface fans—installed in parallel configuration—were commissioned to supply a flow of 165 m³/s underground. When the system was commissioned, the mine noted the flow supply underground was only 145 m³/s, below the original required design flow of 165 m³/s based on requirements for its diesel fleet (Figure 6a). This restricted the operation of production equipment underground and affected planned production targets. The mine suspected leakage issues but could not identify any sources.

Figure 6. Case Study 8: The effect of autocompression on raise flow distribution in a) incorrect design and b) correct design

An inspection indicated that the designer made a fundamental error in design: they failed to incorporate the effect of autocompression when determining the fan flow. The surface fans were sized to supply a flow of 165 m³/s when they should have been sized for a flow of 185 m³/s (Figure 6b). The fan total pressure was incorrectly determined (2.5 kPa versus required 2.8 kPa) and the motors were undersized (260 kW versus required 335 kW). Unfortunately, the new fans did not have the capacity to supply the required flow of 185 m³/s at a total pressure of 2.8 kPa. Also, the installed motors were hugely undersized by 75 kW each. In this case, a new source of fresh air had to be procured to make up the additional required flow of 20 m³/s underground.

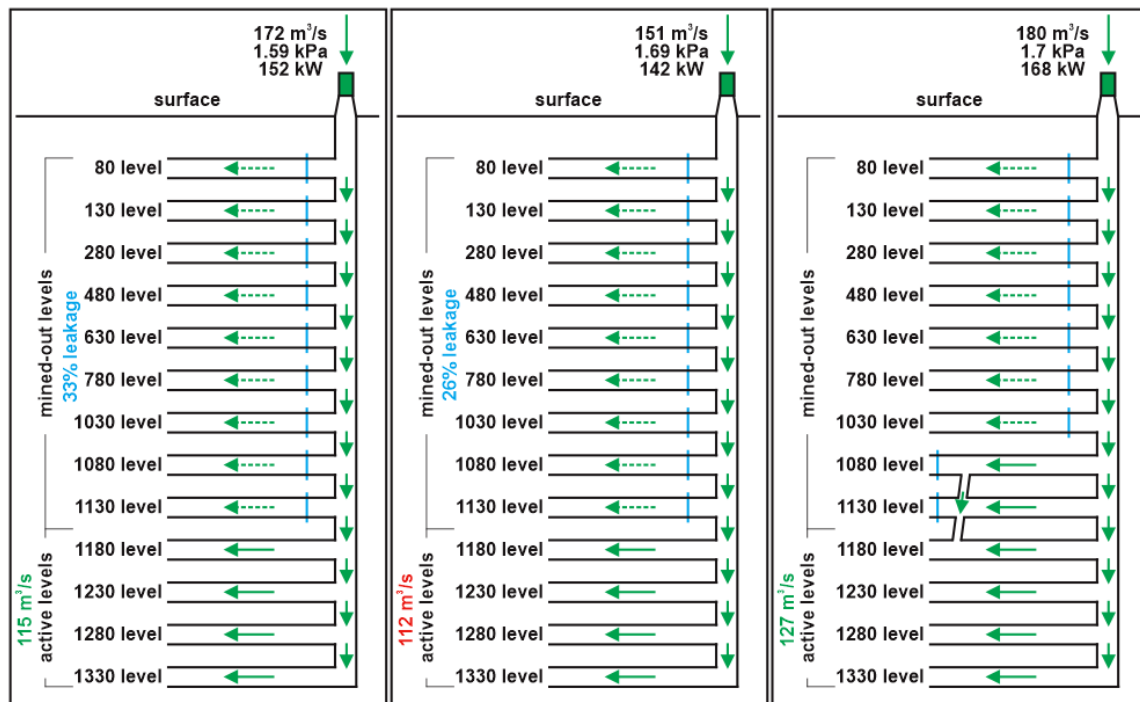
The mine had four active levels and nine mined out levels. The surface fans were delivering 172 m³/s and, with a leakage of 33% at raise connections to the 9 inactive levels, the flow reaching the active mining area was 115 m³/s, slightly above the minimum flow requirements (Figure 7a). The fans were operating at a total pressure of 1.59 kPa, and the brake power was 152 kW (Figure 8, point A). The raise resistance pressure was 1.34 kPa.

Figure 7. Case Study 9: Ventilation system schematic a) under original conditions, b) after leakage control and c) under final conditions

In order to increase the airflow volume in the active levels, the mine worked at reducing leakage by approximately 7% by sealing off and shotcreting all bulkheaded raise connections to the nine inactive levels. During completion of the remedial work, a survey conducted by the mine indicated that the flow in the active levels had actually reduced to 112 m³/s, slightly below the minimum flow requirements (Figure 7b). Mine personnel were perplexed and could not understand the cause for the reduction in fan flow.

To correct the situation, two actions were taken. The raise resistance pressure was first decreased by transferring air to the active levels via mined out levels and old ore passes (Figure 7c). The fans blade setting were then changed—within the constraints of the motor size—and the flow reaching the lower active levels were increased to the point where normal mining activities could be resumed (Figure 8, point C).

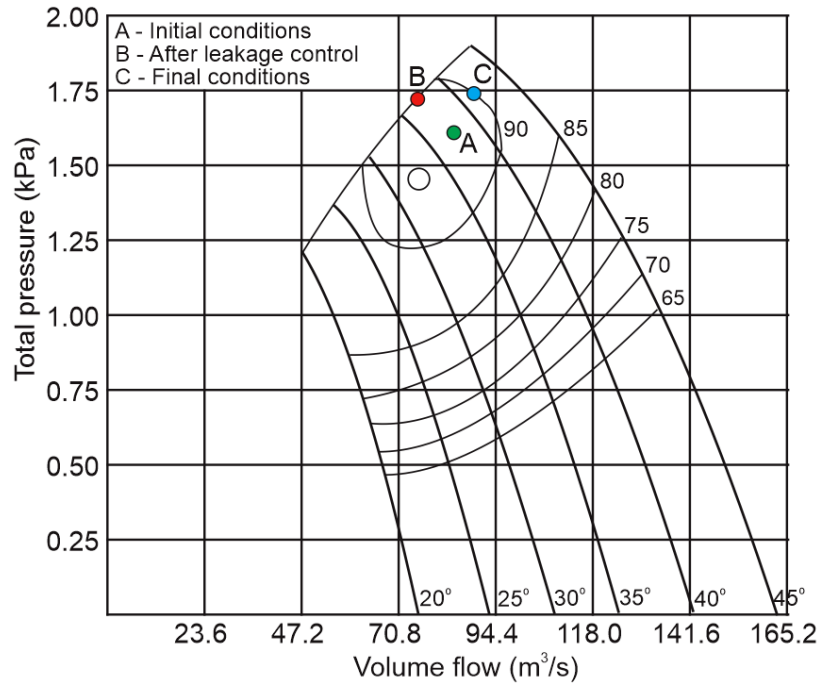
Figure 8. Case Study 9: Fan operating conditions

In an engineering assessment, it was noted that by sealing of the raise connections, the raise resistance pressure was increased to 1.44 kPa. In effect, the fan operating point was changed to 151 m³/s at 1.69 kPa. The fan was operating very high on the curve at the outset of stall (Figure 8, point B). Sealing off the raise connection did not change the raise resistance but increased the resistance pressure, compromising the mine operation. The mine was advised that, prior to reducing leakage in airways or ventilation ducts, they must carefully investigate the effect of the associated increase in resistance pressure on the linked fans.

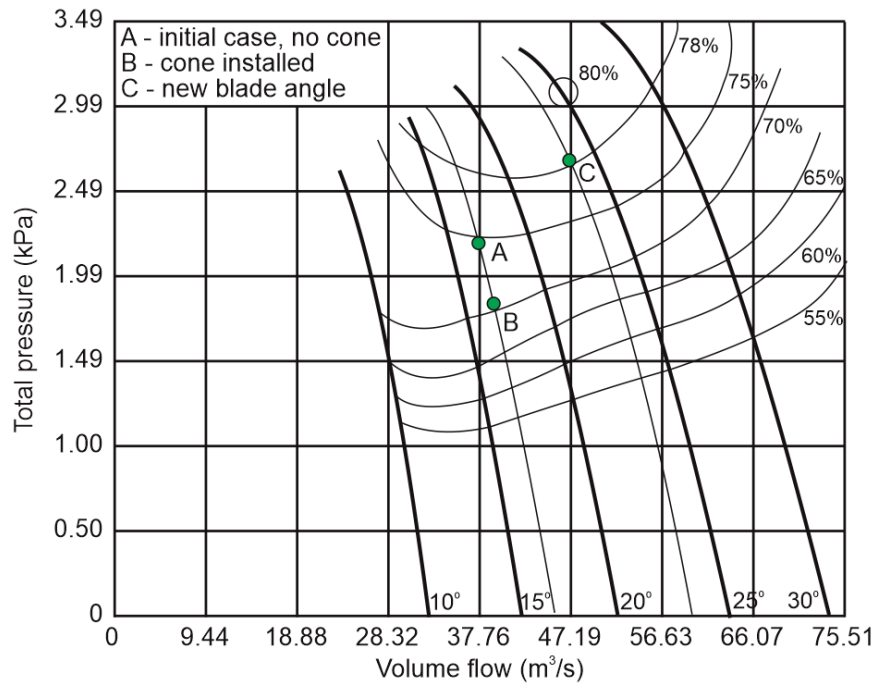
A ventilation survey at the fan station indicated a stable fan operation, falling within its design operating point of 37.8 m³/s at 2.1 kPa total pressure. The fan efficiency was 75%, and the brake power was 104 kW. Figure 9 point A shows the fan curve and initial operating point. However, the air velocity in the raise was estimated at 8.3 m/s, and it was thus contemplated that water blanketing could be affecting the fan performance since the air velocity for water blanketing to become critical is approximately 8 m/s.

Figure 9. Case Study 10: Exhaust booster fan curve and operating points

Psychrometric surveys indicated the air entering the raise was under full saturation conditions. When the spent saturated air was transferred by the fan and rose in the raise, water was being condensed out of the air. The droplets formed stayed suspended in the air within the raise, gradually increasing the resistance pressure. It seems that it was taking approximately 6 months for the water blanketing associated resistance to increase to the point of fan stall.

A two-step control solution was proposed and implemented. The first step included a low-cost retrofit of simply installing an efficient, 1.24 m long cone with an 1.83 m outlet diameter. The fan flow increased to 39.2 m³/s, and the fan total pressure dropped to 1.84 kPa. Even though the fan operating point was now much lower on the fan curve (Figure 9, point B), the air velocity within the raise (8.6 m/s) was still within the critical air velocity range.

In the second step, the fan blade angle was adjusted to 23 degrees and operate at a flow of 47 m³/s (Figure 9, point C), bringing the raise air velocity to 10.4 m/s, outside the critical velocity range. The fan total pressure was now 2.68 kPa, the efficiency increased to 78%, and the brake power at 162 kW. With these simple, low-cost, procedural remedial actions the raise exhaust capacity was increased and the fan
